Central High School Walk Audit of Central Ave./MD 214 Debrief

WABA Youth Organizer,
Joseph Hamd coordinated
the audit

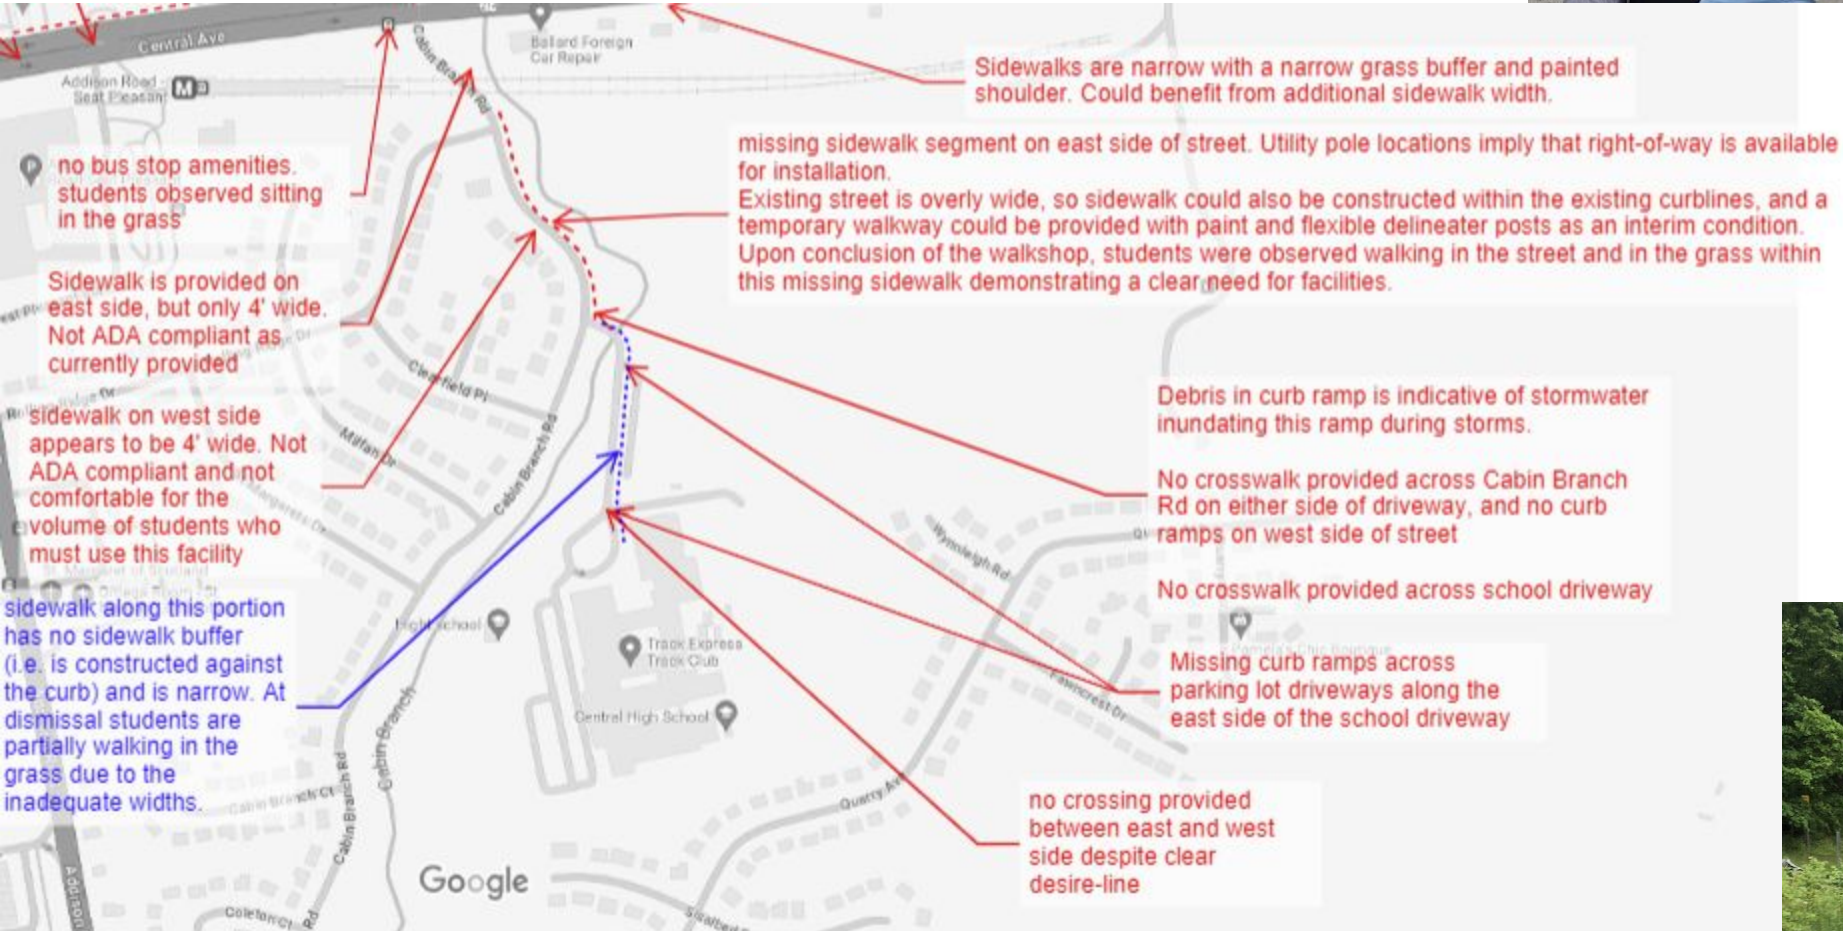
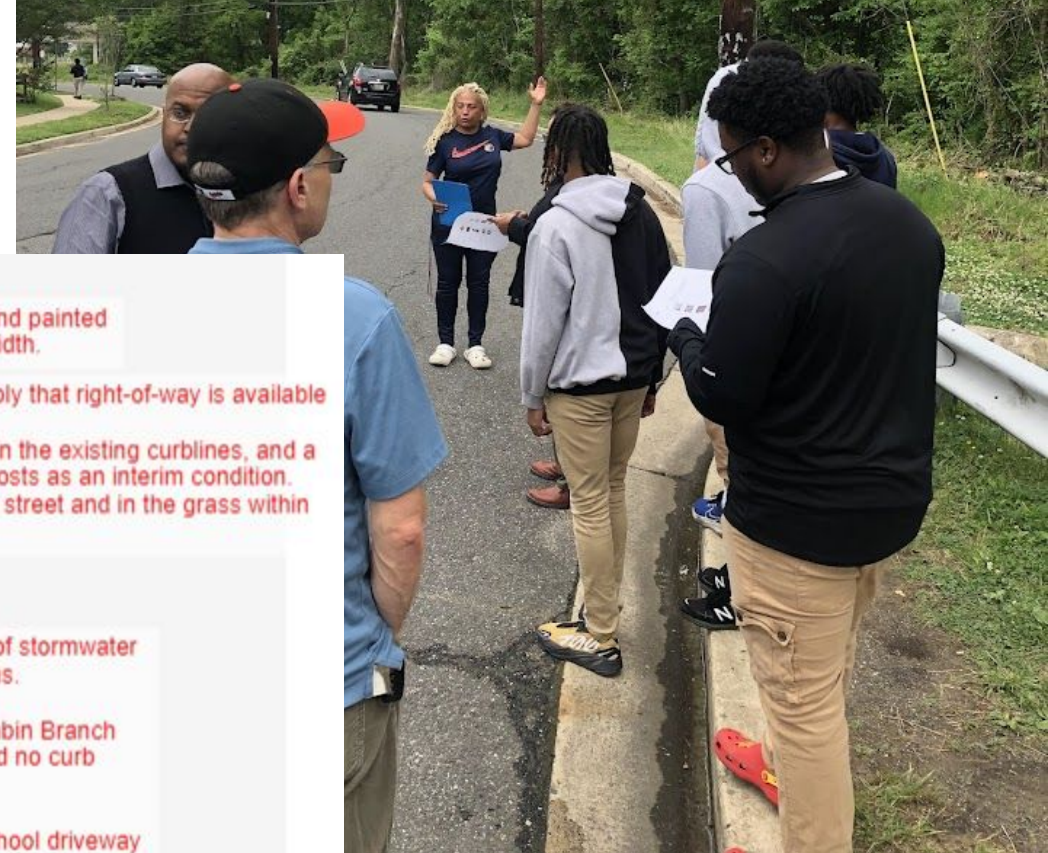
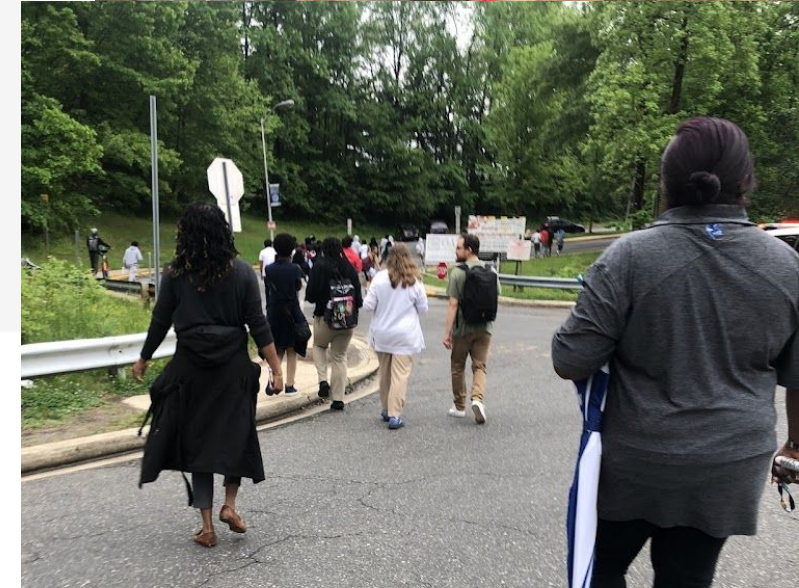
Cabin Branch Road (county) connecting school to MD 214

- Missing sidewalk on east
- No crosswalk from west sidewalk to school drive
- Overly wide road
- No buffer on west sidewalk
- Path connections from West & South

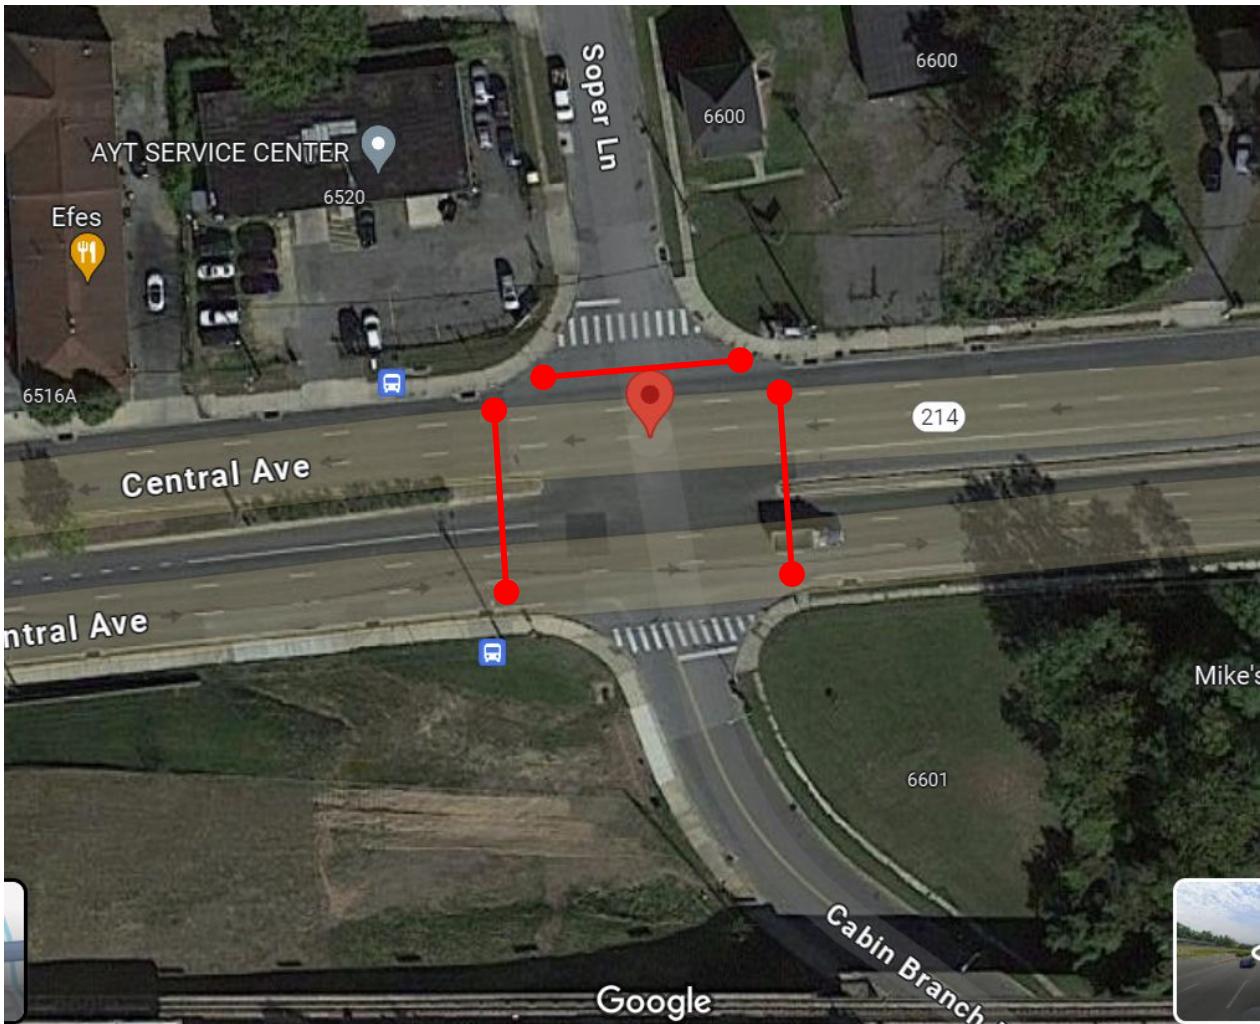
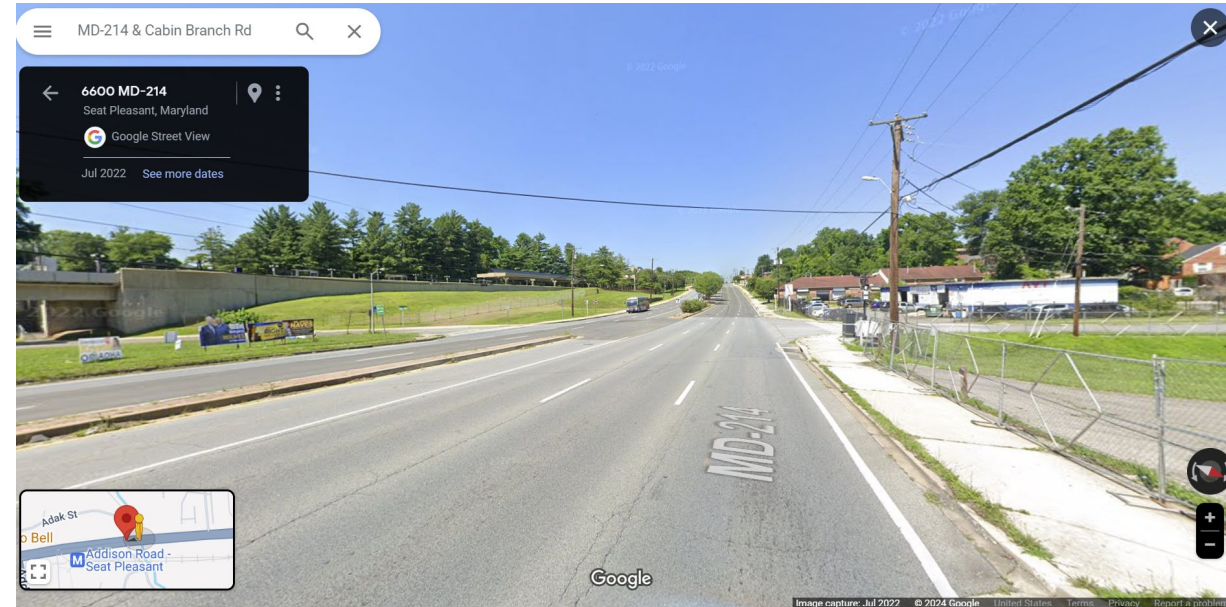
MD 214 & Cabin Branch Rd

- No crosswalk
- No signal (for peds, left turns, bus stops)
- Overly wide, high speeds
- No bus stop amenities
- Large corner radii
- Long crossing distance

Intersection of Cabin Branch Rd
1) No crossing provided across bus stop on North side. Location of bus stop is problematic. Drivers trying to turn left from Central Ave and are making risky turns to avoid the bus stop.
2) Corner radii and crossing distances are long, making it difficult for higher speed motorist turns and increasing crossing distances.

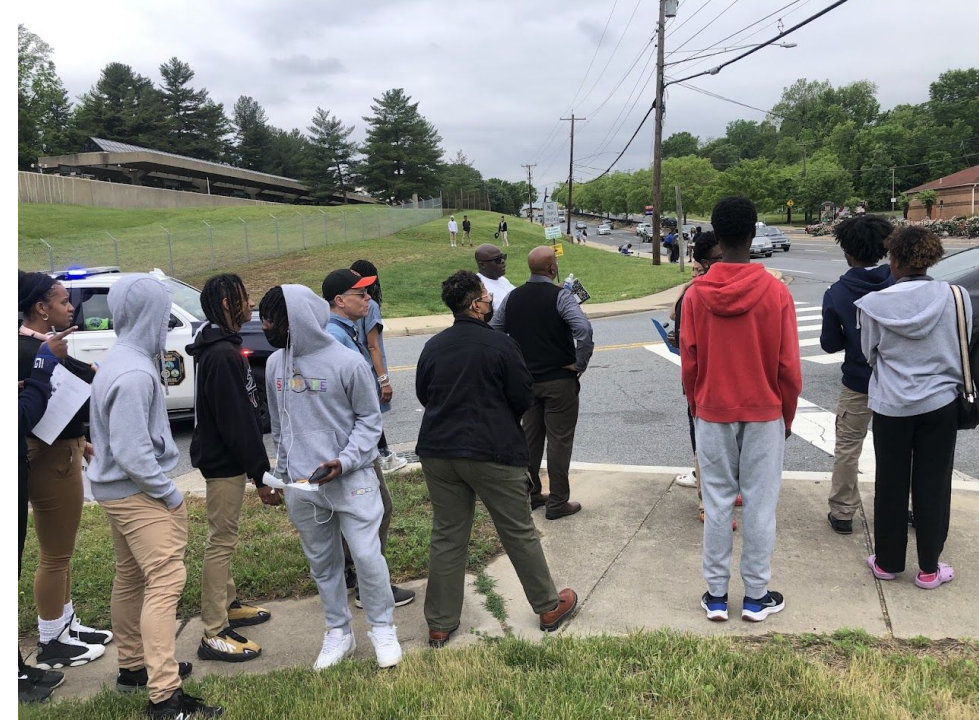
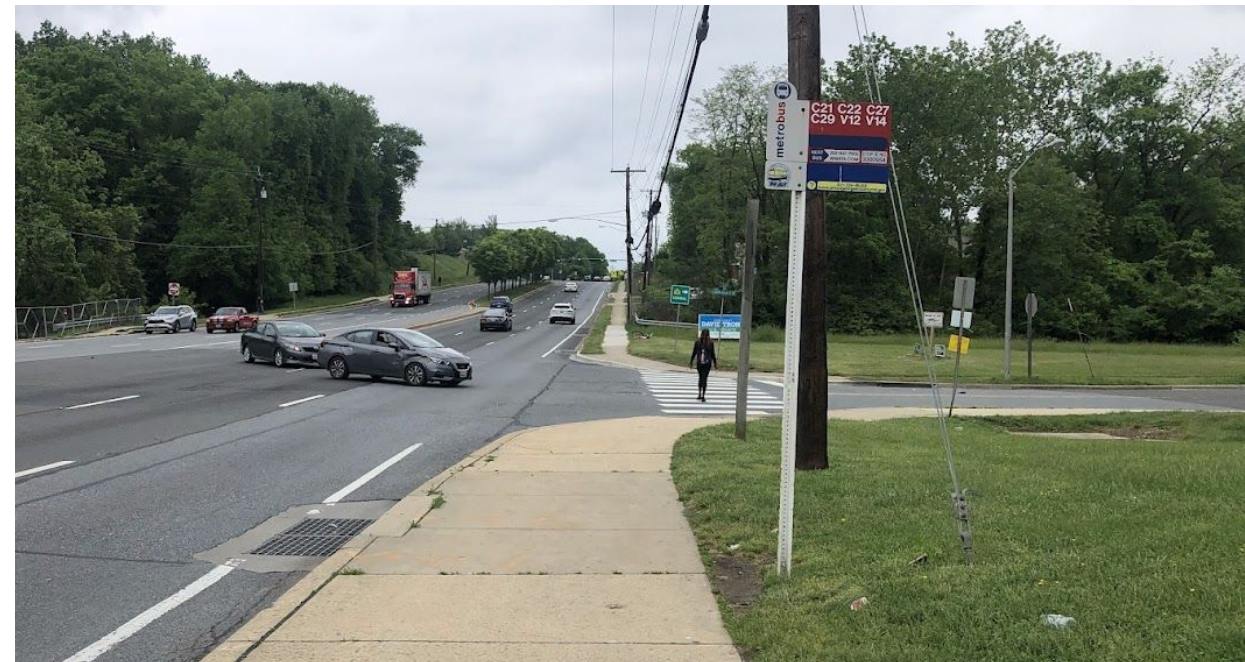
Central Avenue

- Narrow sidewalks
- No/small buffer
- Multiple driveway aprons

Sidewalk includes no buffer from curbline and no painted shoulder resulting in uncomfortable walking conditions. Driveway aprons to non-existent driveways are prevalent, creating uncomfortable walking conditions and drainage issues. Some existing driveways appear unnecessarily large. For example, the Dunkin' exit driveway serves egress movements only and could be narrowed. Similarly, the Blue Sky Liquor store has two driveways which could either be narrowed or consolidated.

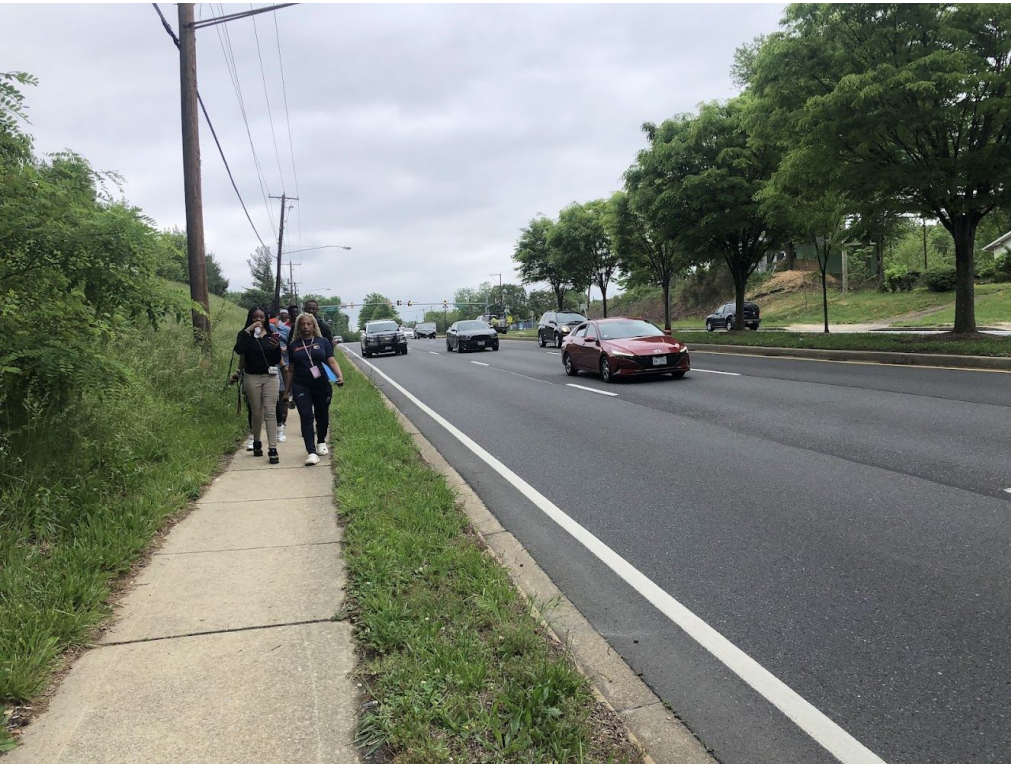
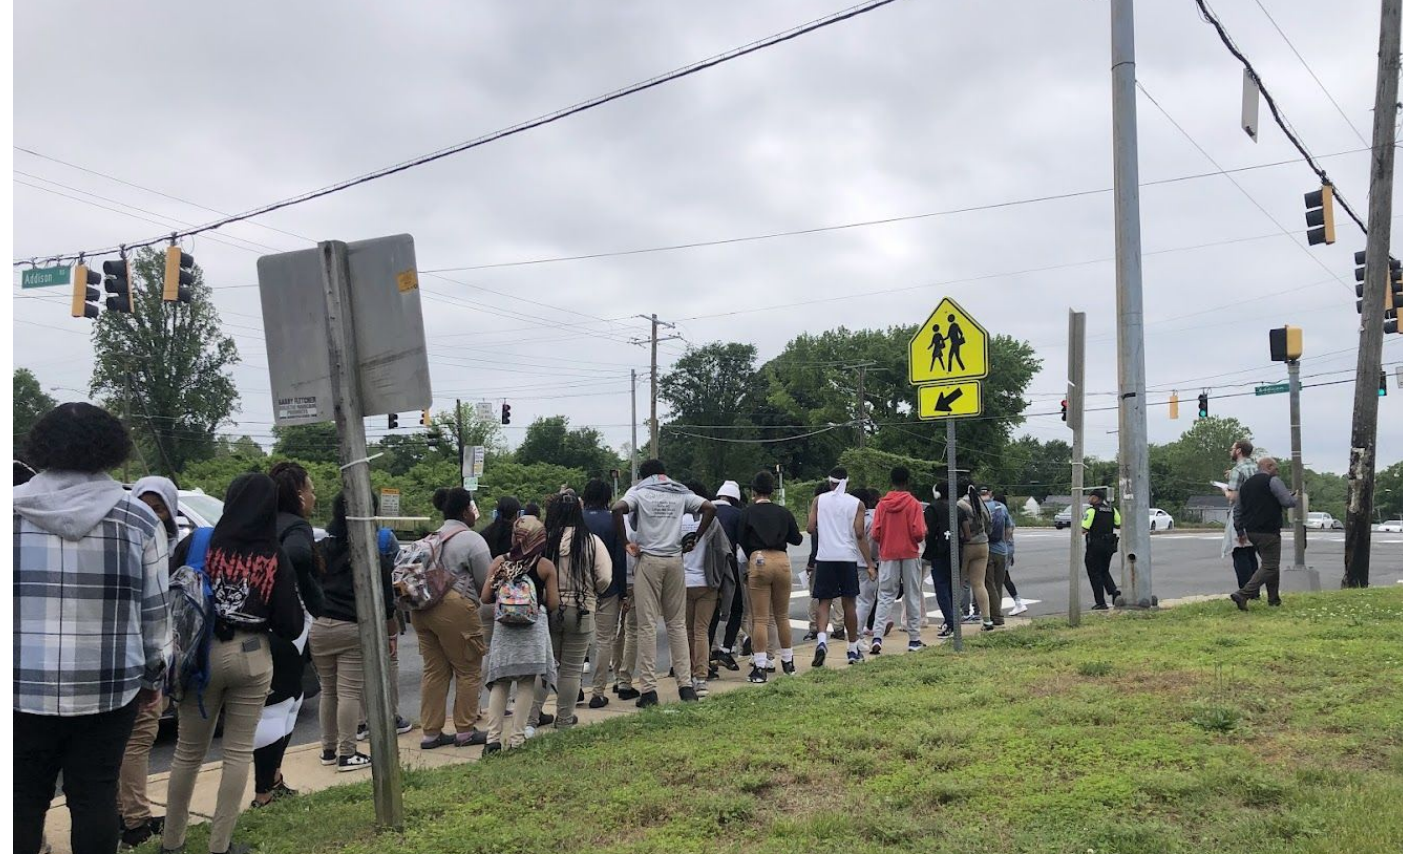
Student observations:

- Narrow sidewalks
- Too close to cars
- Driving fast

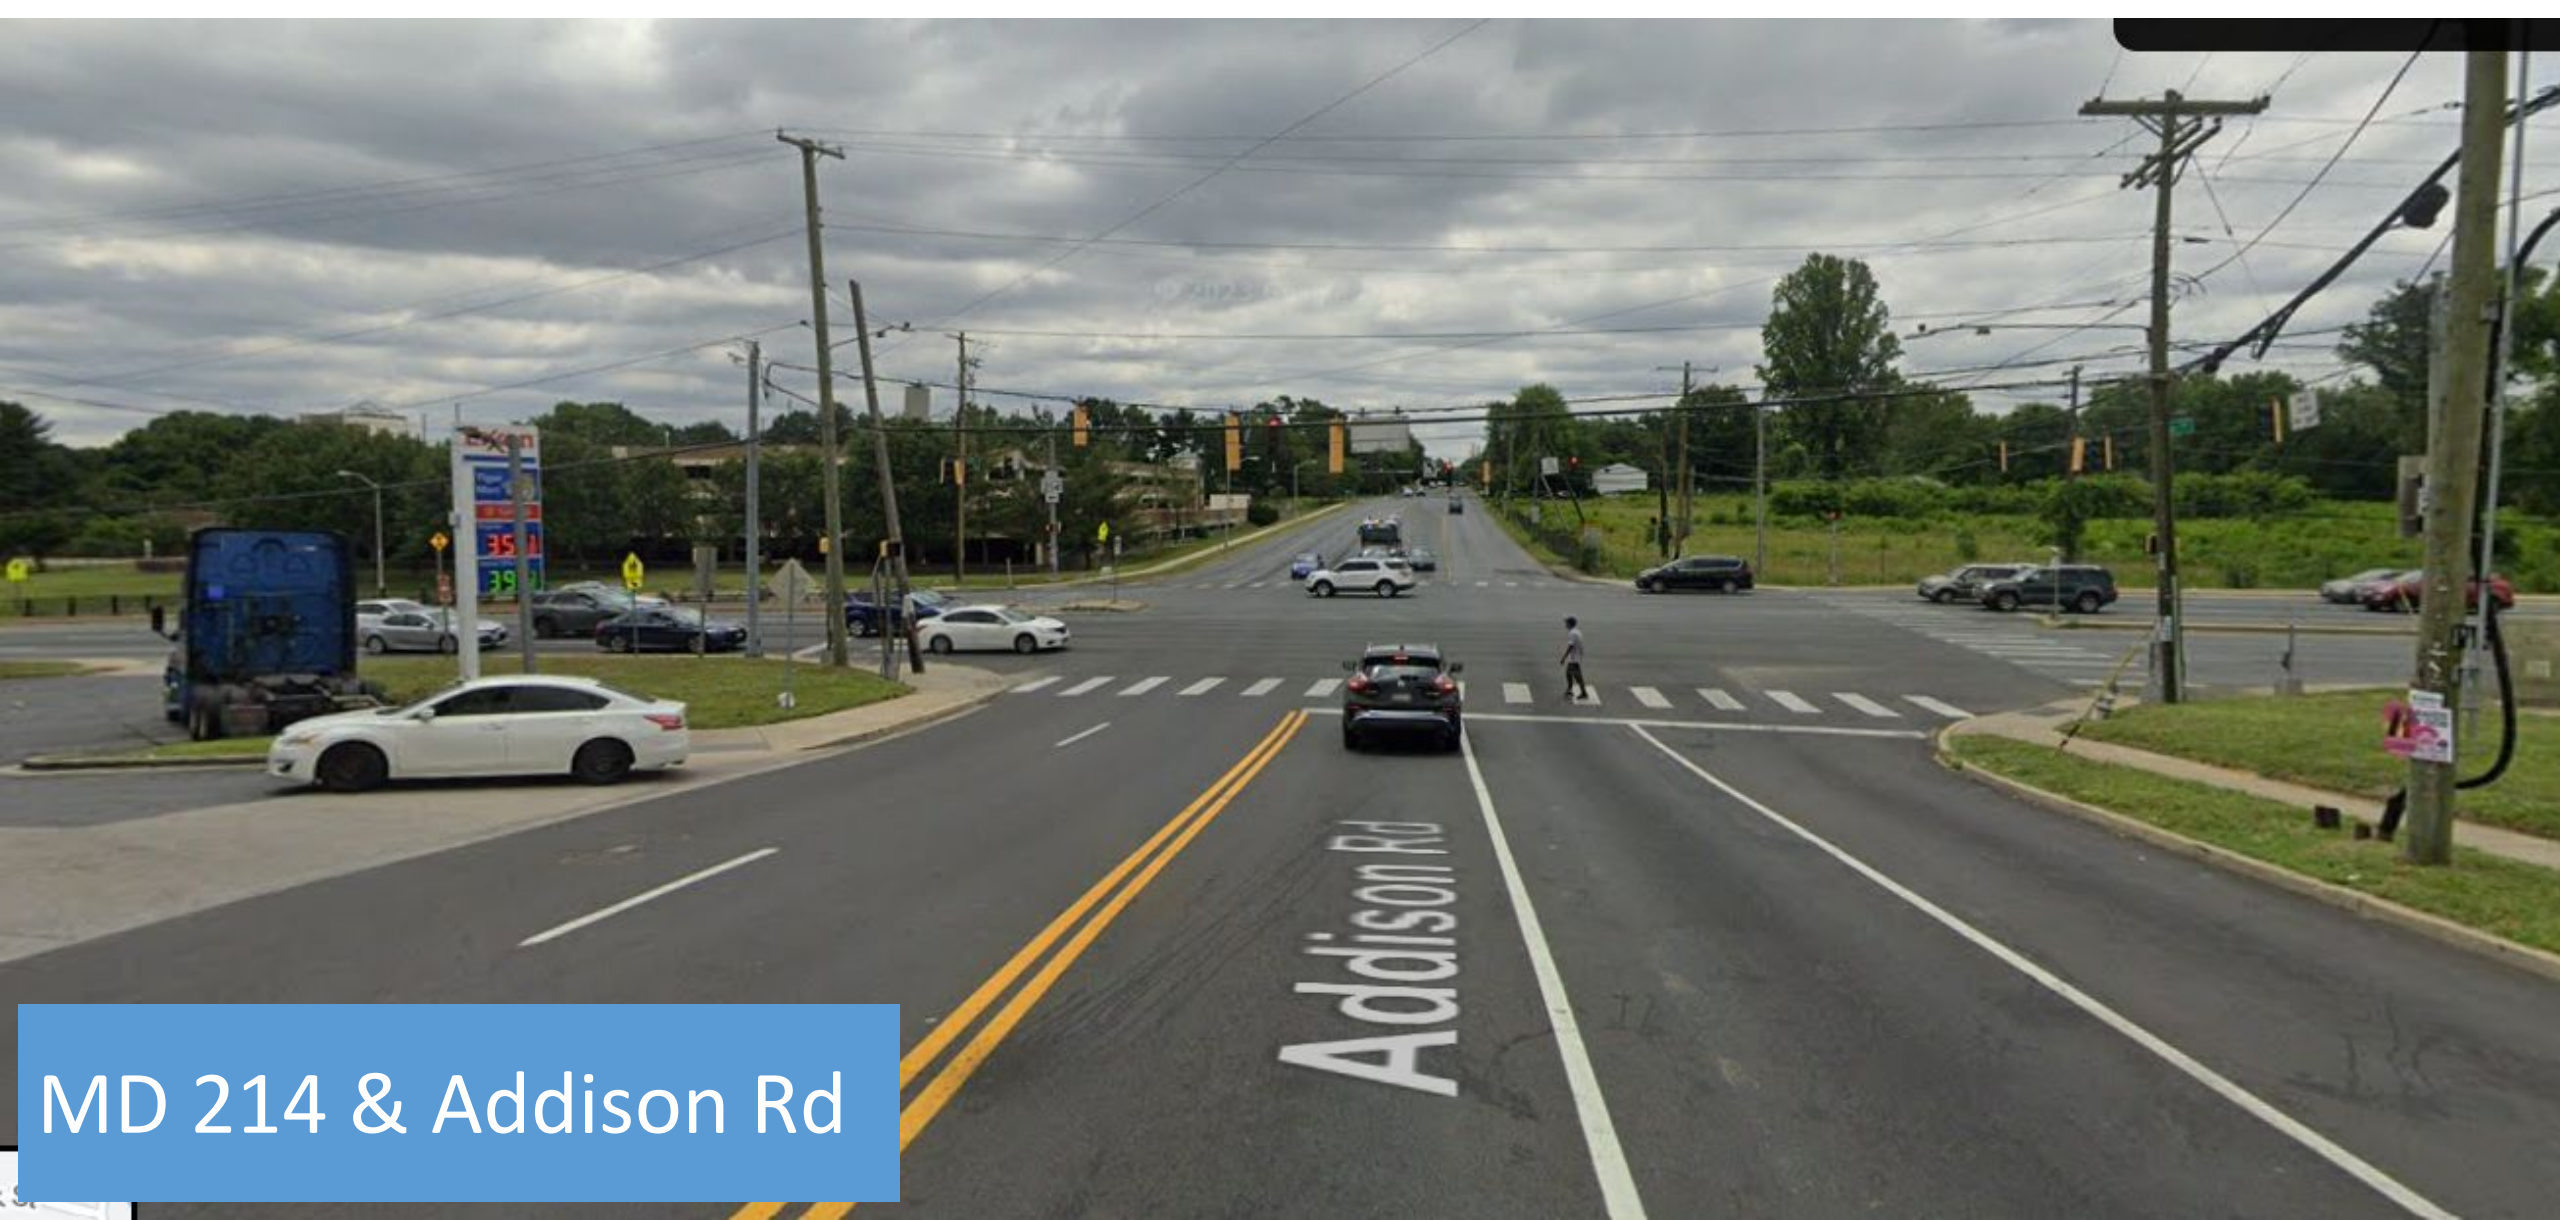
MD 214 & Addison Rd

- Overly wide roadway - 6 lanes for 4 lanes of traffic volume
- High speeds: 58 mph 85th percentile, 30 mph limit
- Large turning radii
- Long crossing distances

1) Diagonal curb ramp (i.e. one curb ramp that serves both directions of travel) exists on the Southwest corner. Diagonal ramps are not permitted by the ADA unless two separate ramps or a blended transition are technically infeasible. Appears curb radius could be reduced to provide separate ramps.
2) Most push buttons at this intersection appear to be non-ADA compliant for the minimum 10-inch reach requirements.
3) Pole in middle of sidewalk, and narrow widths, on the Northeast corner make conditions uncomfortable for pedestrians.

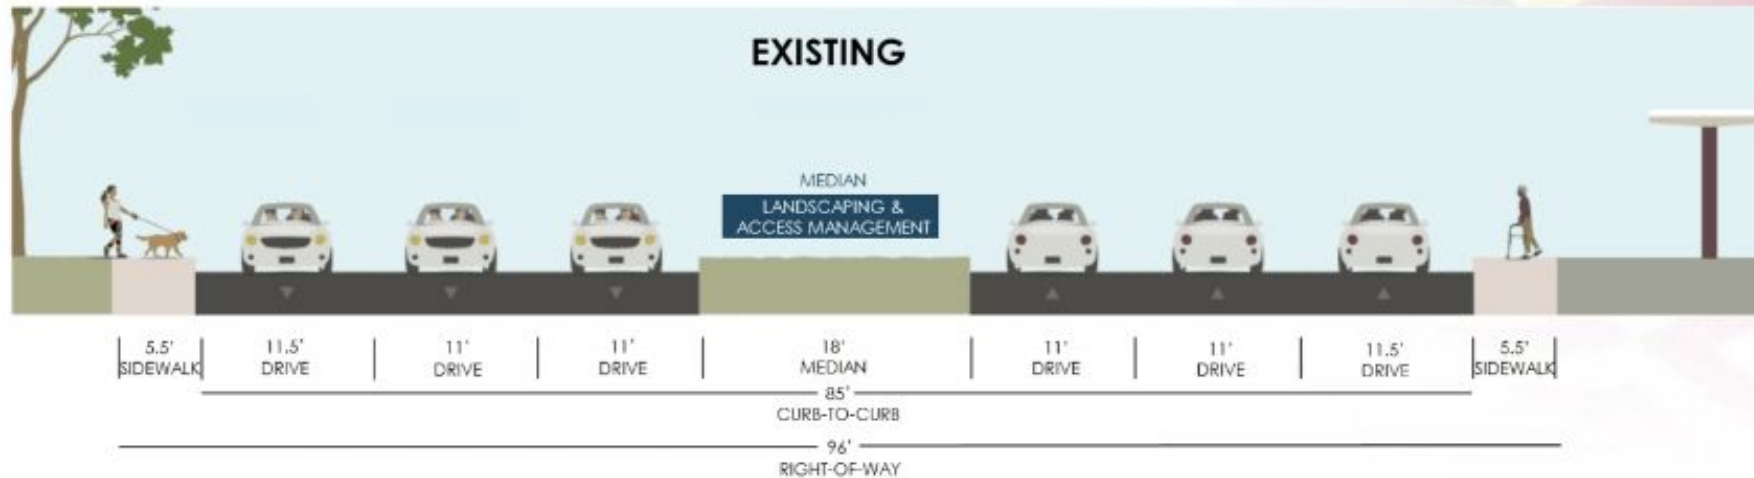
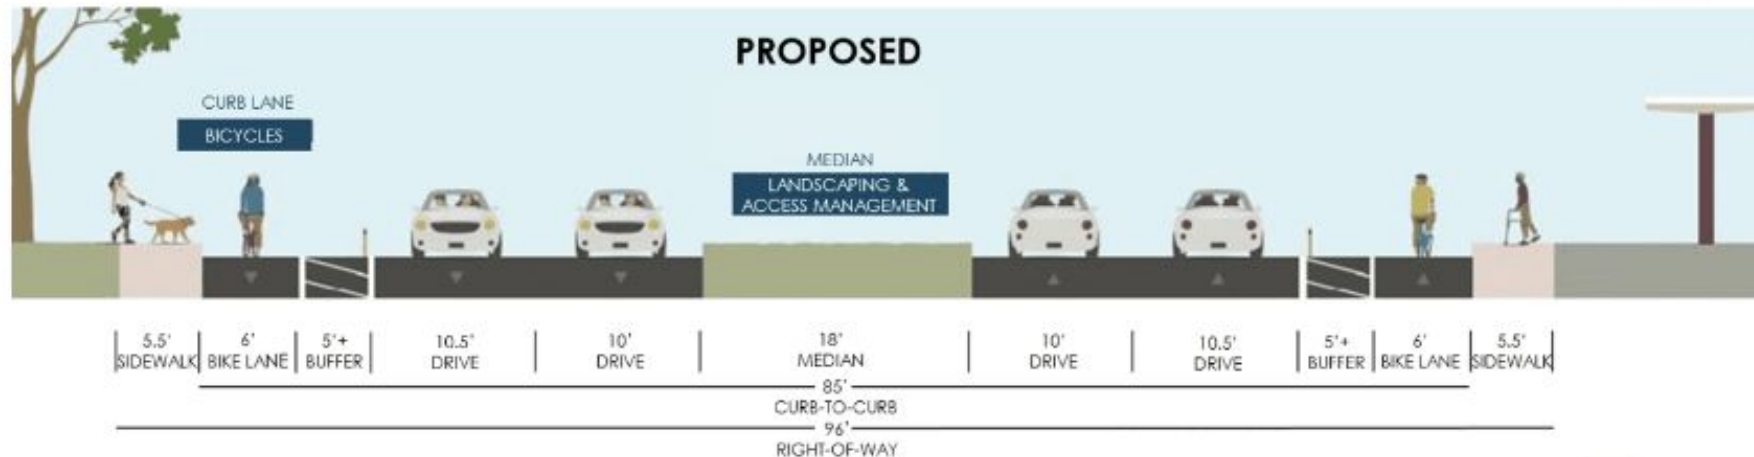
MD 187 TYPICAL SECTION

Road Diet example - 6 to 4 lanes + bike lanes

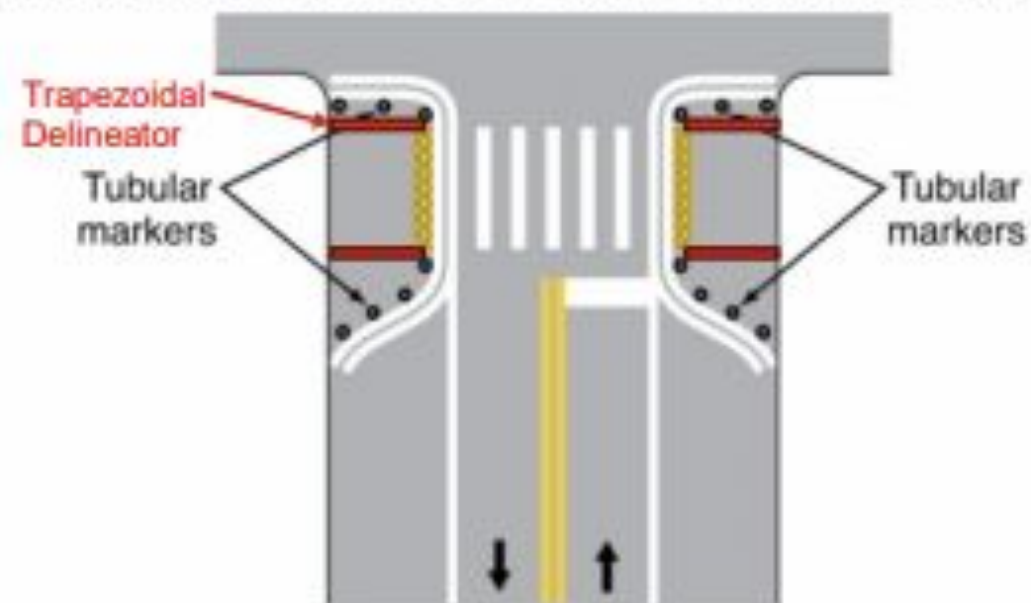
A – Sidewalk extension to reduce the pedestrian crossing distance

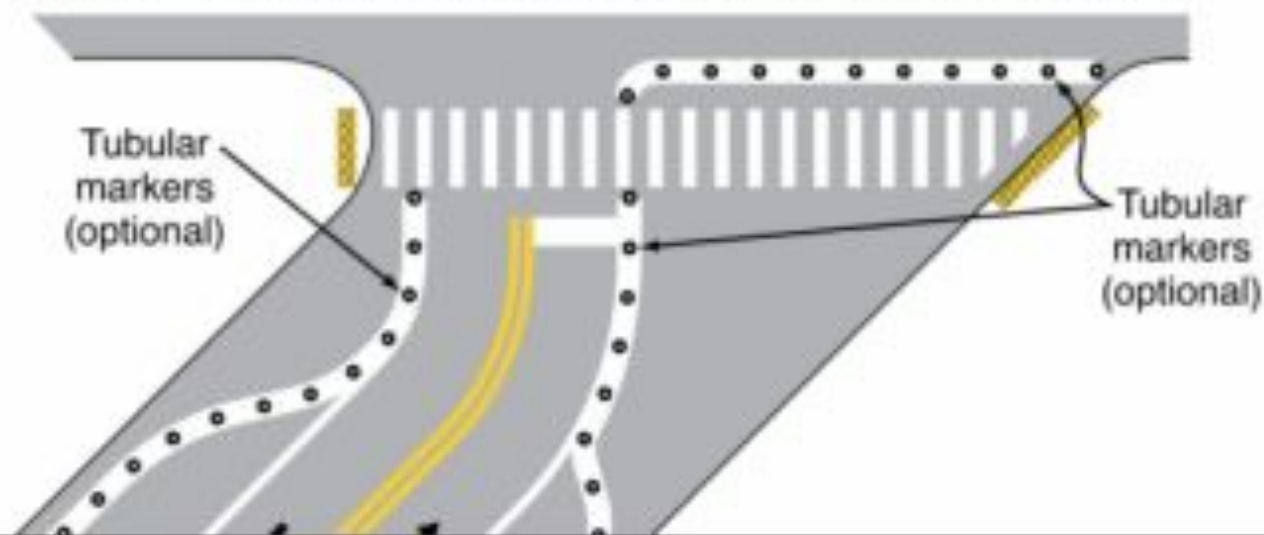
B – Channelizing for speed control and altered travel paths

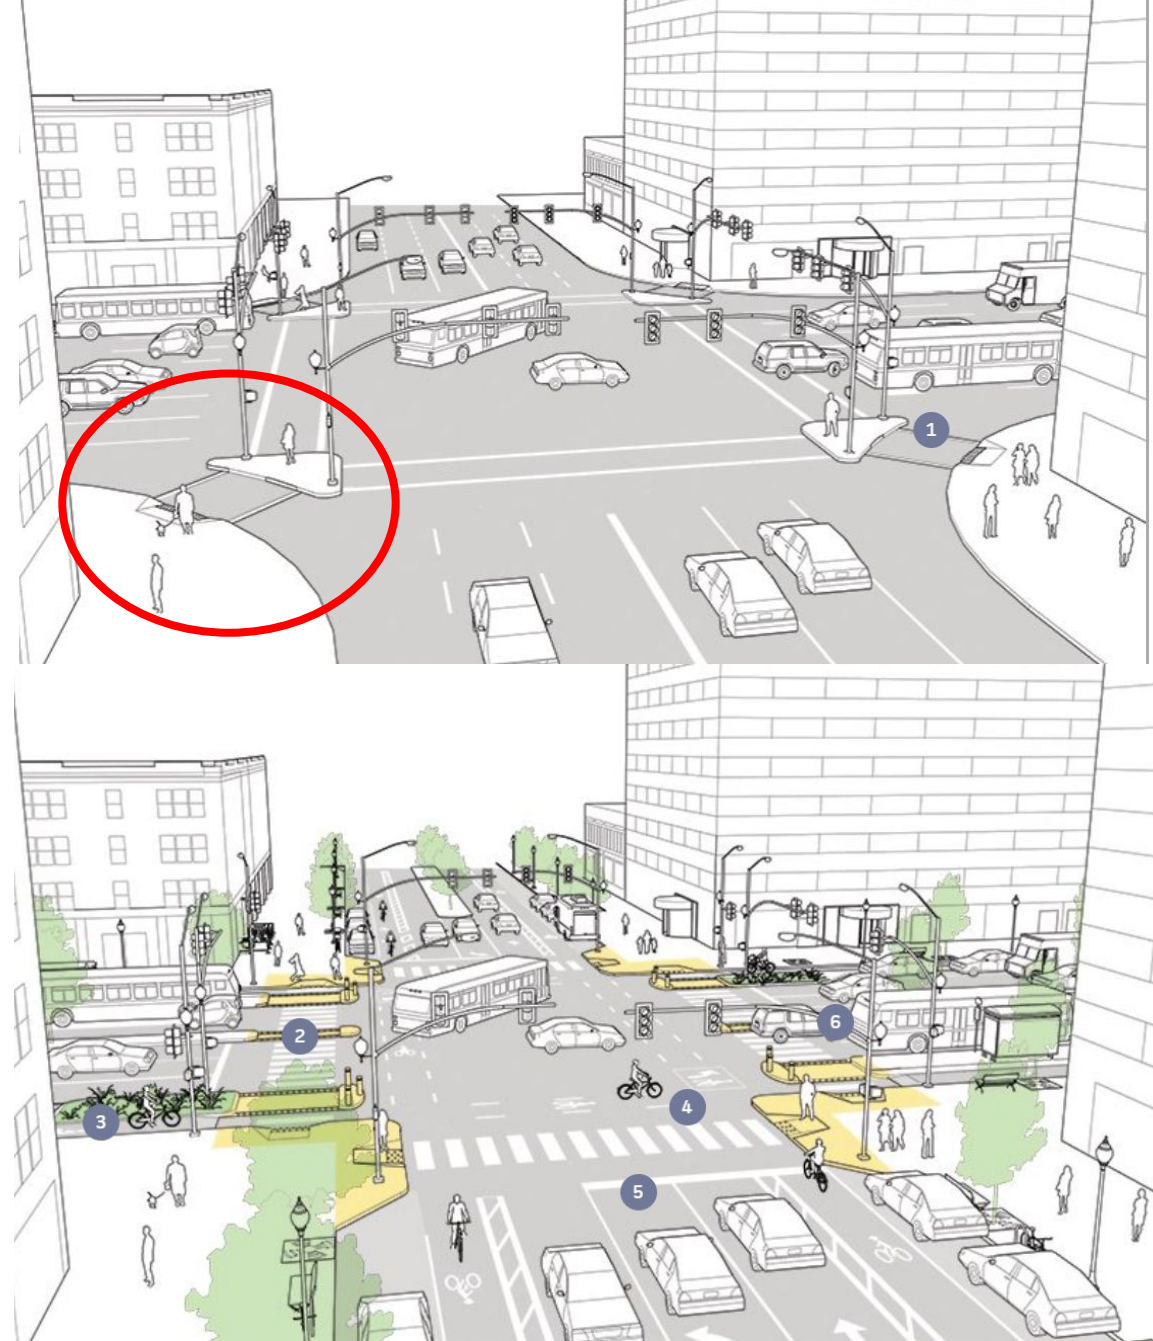
Safer intersections and turns

- Tighter corner turning radius of 15 feet to be a maximum rather than minimum
- Prohibits slip lanes (high speed right turn lanes) and discourages multiple left turn lanes
- Wide crossing distances and high speed turns are a major threat to pedestrians

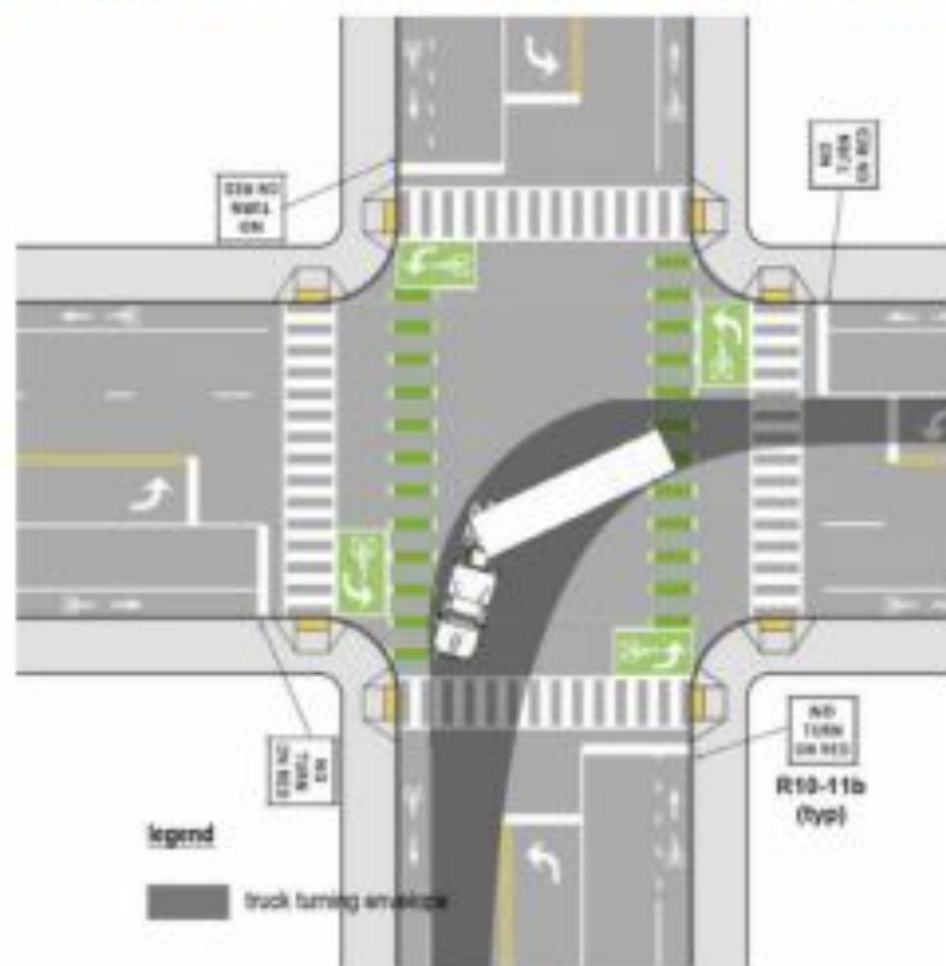
Intersection Pavement Markings

Intersection Type	Condition	Separated Bicycle Lane	Conventional Buffered Bike Lane	Bicycle Boulevard
Signalized	Turn Conflict			No Markings
	No Turn Conflict			No Markings
	Bikeway Corridor Turns Left
